SOUTH AFRICAN NOTICE TO MARINERS

JULY 2002 EDITION

**PUBLISHED MONTHLY
BY THE
HYDROGRAPHIC OFFICE
CAPE TOWN**

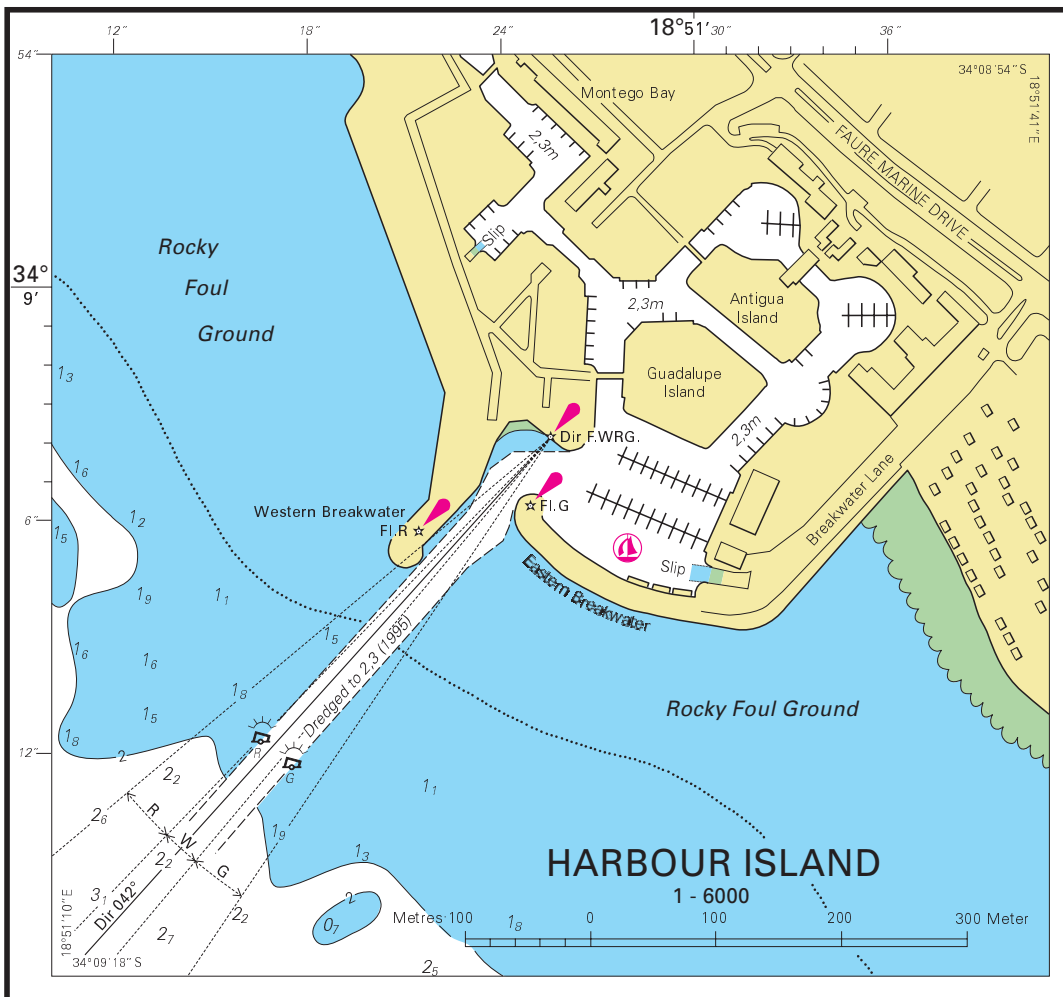
To accompany Notice to Mariners 67 of 2002
SAN SC 4

1. Insert : the accompanying block corrections for Harbour Island inset.
2. Replace : Existing Sailing Directions text for Harbour Island.

HARBOUR ISLAND is a private marina development midway between Strand and Gordon's Bay. The seaward entrance is via a curved breakwater to the E and S and a doglegged breakwater to the W. The entrance channel, 30m wide, with at least 2,3m water, runs along a line of bearing 042°/222°(T) from the harbour mouth. It is marked by a pair of unlit can buoys, coloured red and green and fitted with radar reflectors. There are red and green flashing lights exhibited on the Western and Eastern breakwaters. The channel is marked by a fixed Red/White/Green directional light.

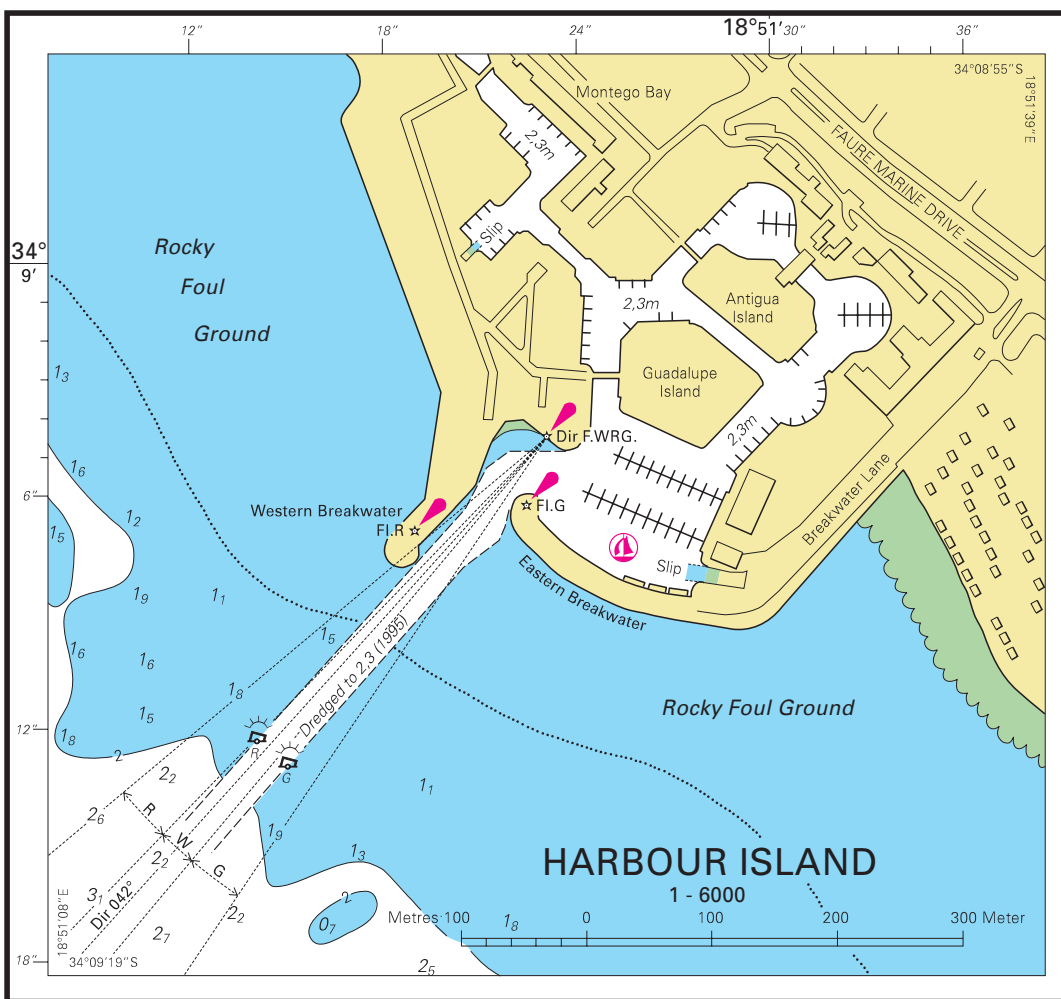
To accompany Notice to Mariners 67 of 2002
SAN SC 5

HARBOUR ISLAND is a private marina development midway between Strand and Gordon's Bay. The seaward entrance is via a curved breakwater to the E and S and a doglegged breakwater to the W. The entrance channel, 30m wide, with at least 2,3m water, runs along a **line of bearing 042°/222°(T)** from the harbour mouth. It is marked by a pair of unlit can buoys, coloured **red** and **green** and fitted with **radar reflectors**. There are **red** and **green flashing lights** exhibited on the Western and Eastern breakwaters. The channel is marked by a fixed **red/white/green directional light**. The harbour comprises **tidal walk-on moorings**, distributed in a **public basin** immediately adjacent to the entrance, as well as in **two inner basins** and the connecting **channels** around **two islands** centred in the harbour complex, all of which are **private**. A **public slipway** for the launch and recovery of ski boats, is located inside the SE Breakwater. The harbour is dredged to a depth of 2,3m below Chart Datum. **Visiting yachts** can obtain **temporary moorings** by arrangement with the Marina Operators. Harbour Island maintains a 24 hour radio watch on VHF Channel 71.
