SOUTH AFRICAN NOTICES TO MARINERS

April 2018 EDITION

43/18* SOUTH AFRICA – East Coast – Durban – Single Buoy Mooring.

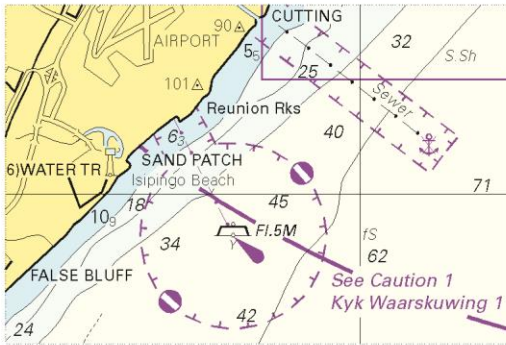
SAN 131

1. Insert: Accompanying block correction in approximate position 30° 00.0' S 31° 00.0' E

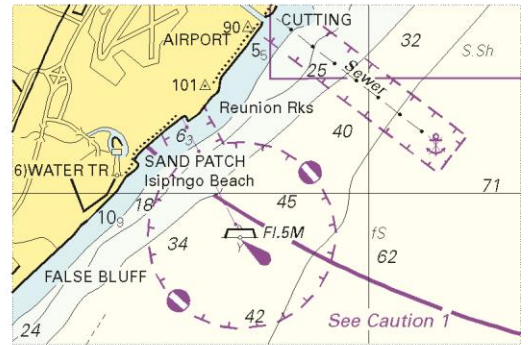
SAN 135

2. Insert: Accompanying block correction in approximate position 30° 00.0' S 31° 00.0' E

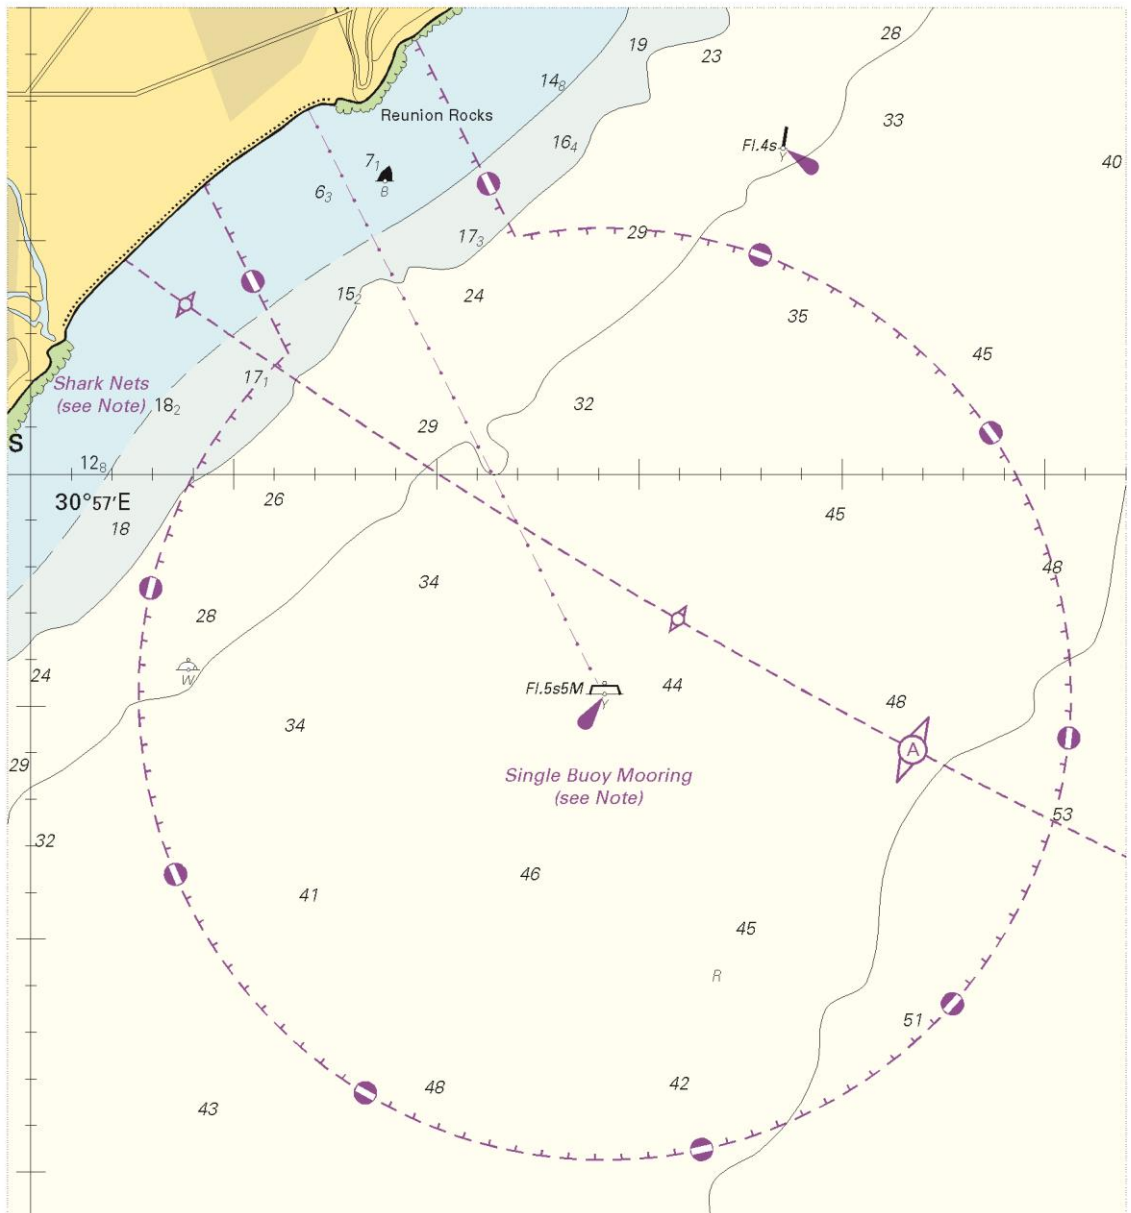
SAN 1029

3. Insert: Accompanying block correction in approximate position 30° 00.0' S 30° 58.5' E
